**NEW MEXICO  
ENVIRONMENT DEPARTMENT**

**Re: CarMax Auto Superstore – Santa Fe, Construction Stormwater; SIC 1522; NPDES Compliance Evaluation Inspection; NPDES #NMR1000UC; January 3, 2018**

## NPDES Construction General Permit Inspection Report – State of New Mexico

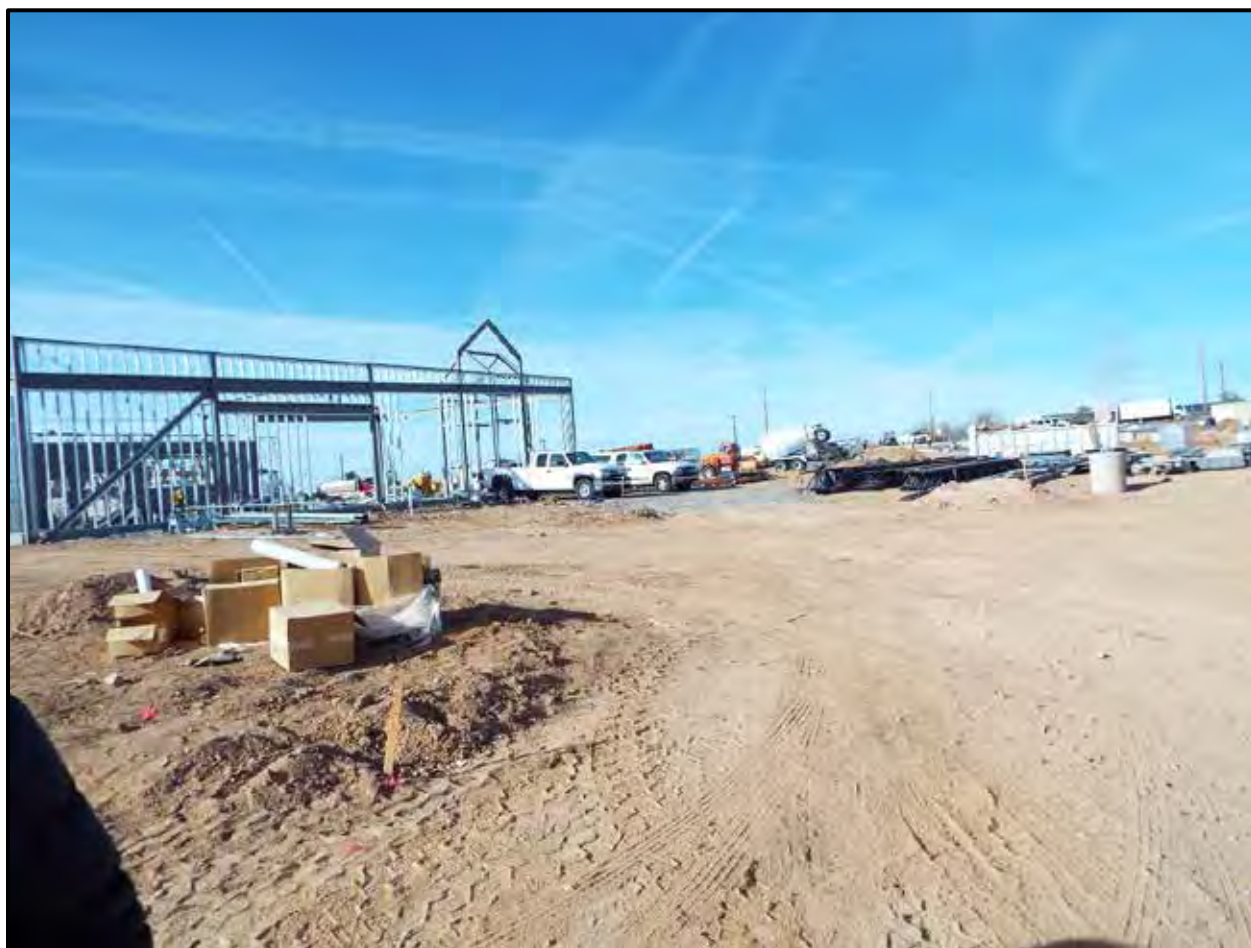
Photo # 1

Photographer: Daniel Valenta	Date: January 3, 2018	Time: 1003 hours
City/County: Santa Fe/ Santa Fe County		
Location: 6820 Cerrillos Road, Santa Fe, New Mexico		
Subject: Construction site for the new CarMax Auto Superstore

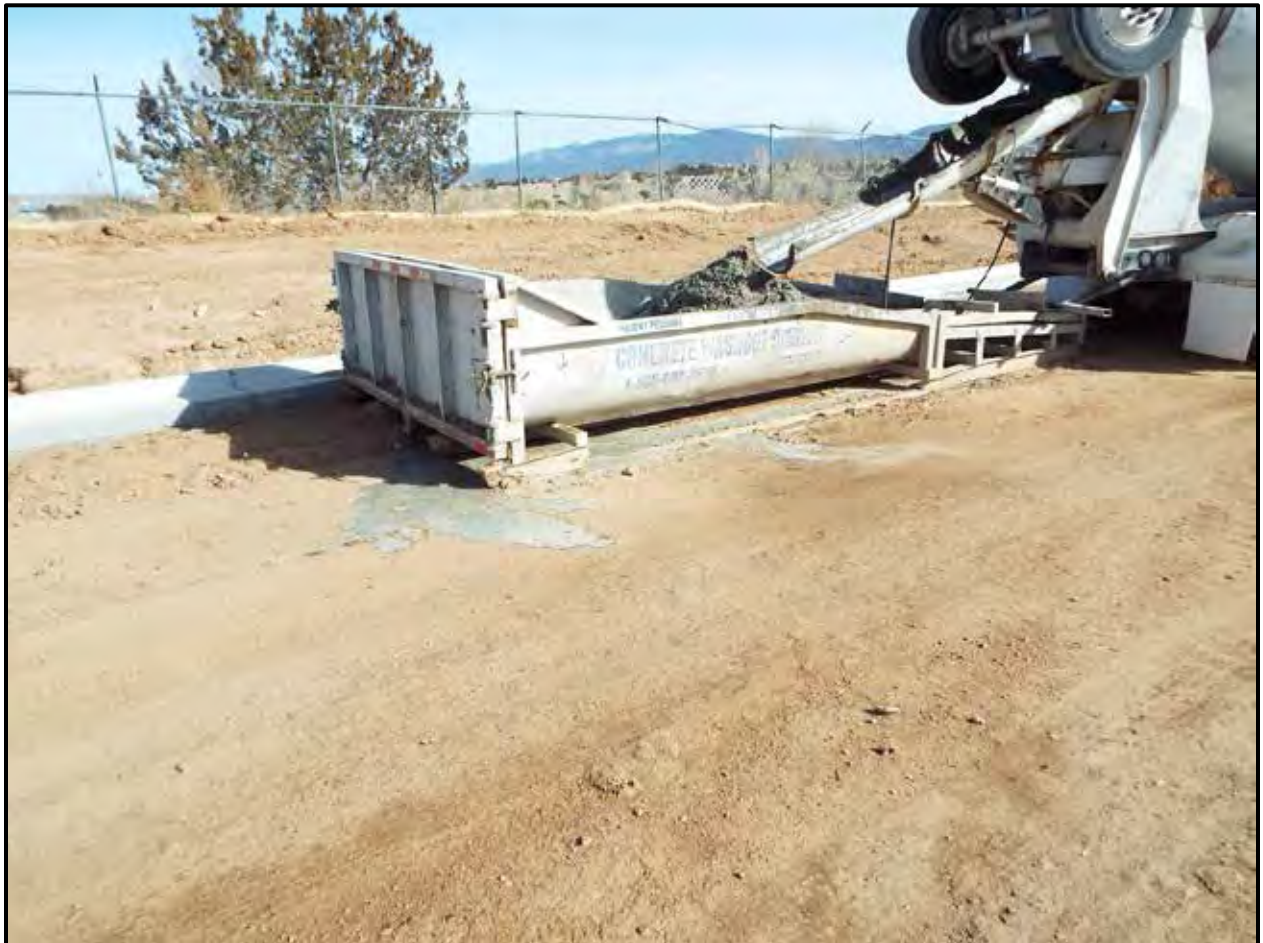
Photo # 2

BMPs implemented on site included mulch sock installation at the north perimeter of the site, which appeared properly installed however the location they were installed served no function, see photo 2. A concrete washout bin was present but was leaking, see photo 2.

Photographer: Daniel Valenta	Date: January 3, 2018	Time: 1050 hours
City/County: Santa Fe/ Santa Fe County		
Location: 6820 Cerrillos Road, Santa Fe, New Mexico		
Subject: Concrete washout leaking onto the ground note waddles at top of slope near the fence.

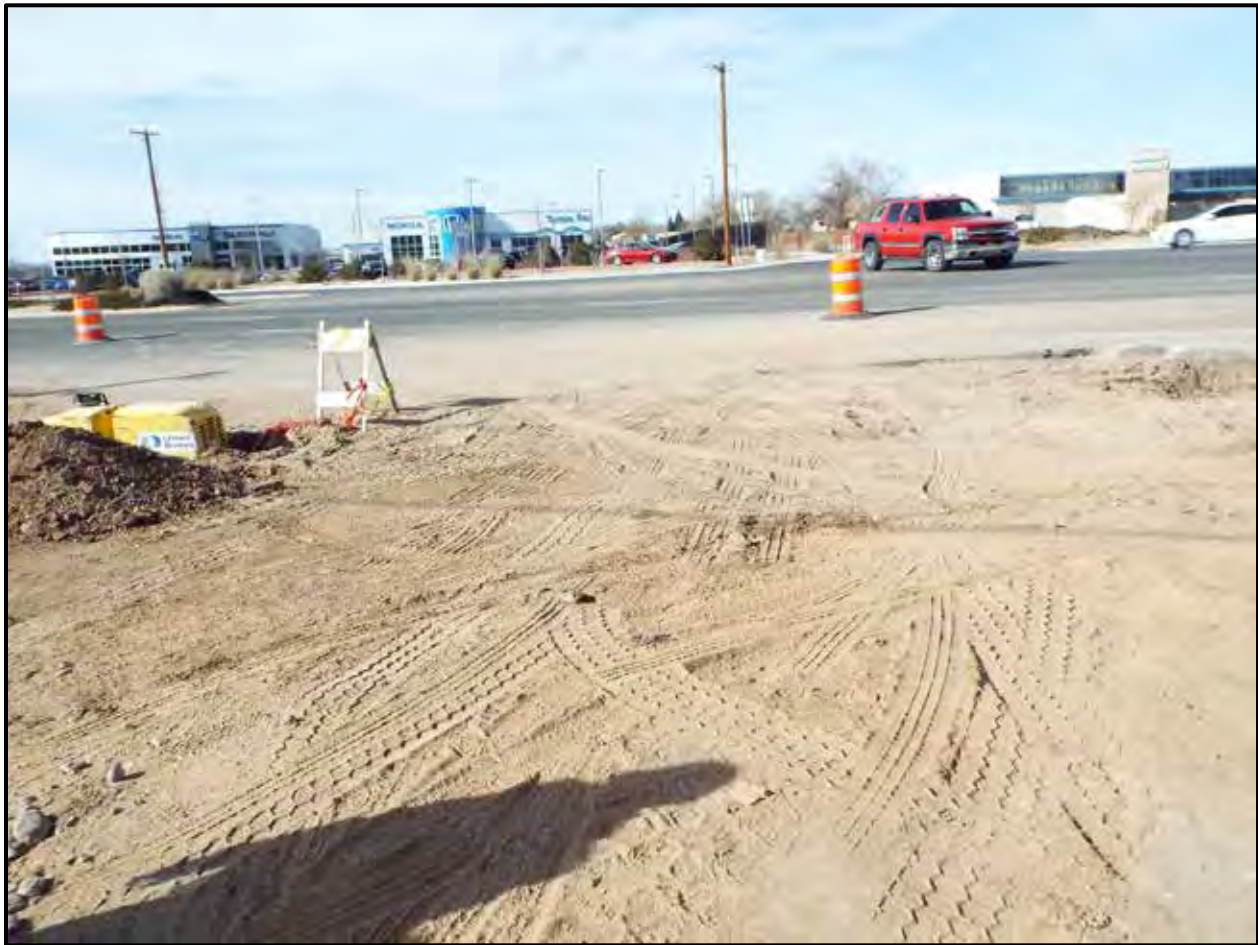
Photo # 3

- No RUSLE evaluation was present in the SWPPP.
- At the time of the inspection, two construction entrances existed. One, with a stabilized apron next to Cerrillos Rd, was considered the exit for track out purposes, see photo 3. The other was considered a working entrance and was not stabilized, see photo 4. A sewage line was being installed and this was the entrance/exit to the Arroyo Chamisos. This area was an undisturbed field.
- On the day of the inspection, there was a dumpster present to collect construction wastes, but without a cover and per the permittee representative not covered at night.

Photographer: Daniel Valenta	Date: January 3, 2018	Time: 1101 hours
City/County: Santa Fe/ Santa Fe County		
Location: : 6820 Cerrillos Road, Santa Fe, New Mexico		
Subject: West entrance/exit onto Cerrillos St.

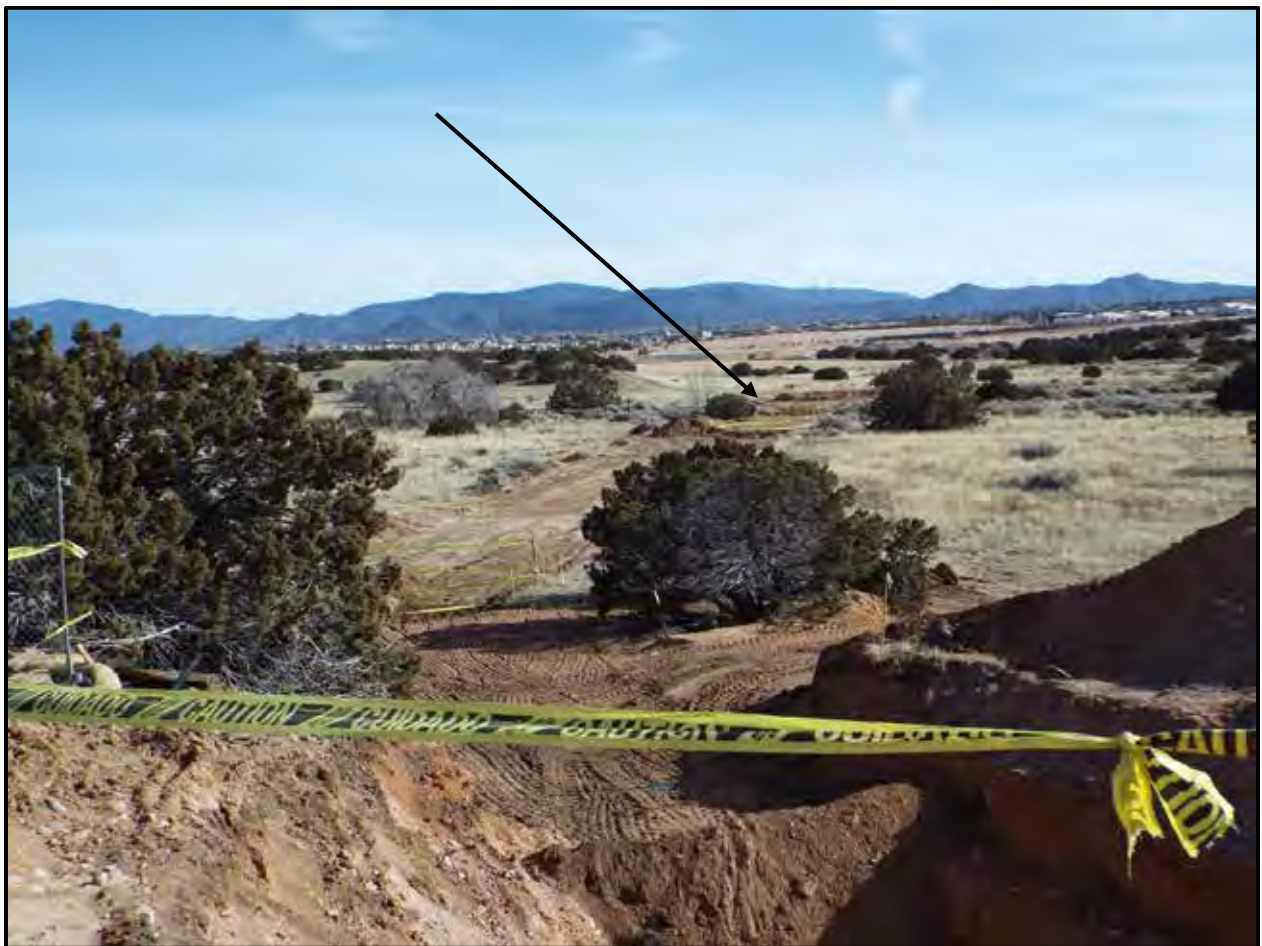
Photo # 4

Photographer: Daniel Valenta	Date: January 3, 2018	Time: 1053 hours
City/County: Santa Fe/ Santa Fe County		
Location: : 6820 Cerrillos Road, Santa Fe, New Mexico		
Subject: East side of construction site. Linear disturbance for new sewage line. Disturbance goes across the Arroyo de los Chamisos.

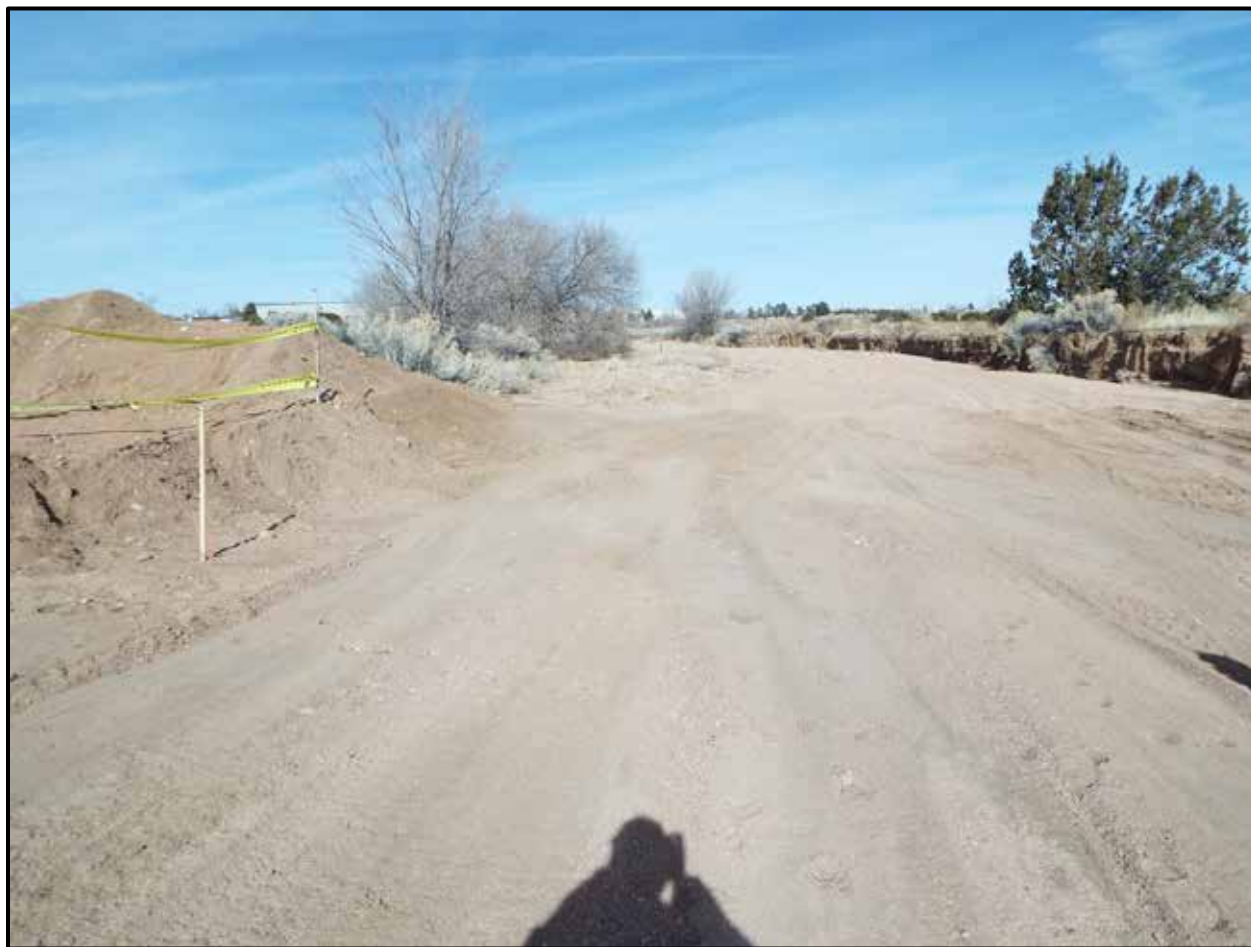
Photo # 5

Photographer: Daniel Valenta	Date: January 3, 2018	Time: 1115 hours
City/County: Santa Fe/ Santa Fe County		
Location: 6820 Cerrillos Road, Santa Fe, New Mexico		
Subject: Soil disturbance up to the edge of the Arroyo Chamisos. The project had an 404 permit to operate within the Arroyo de los Chamisos.
